NASA CR-134355

THIN-METAL LINED PRD 49-III COMPOSITE VESSELS

**THE BOEING AEROSPACE COMPANY
RESEARCH AND ENGINEERING DIVISION
SEATTLE, WASHINGTON**

JANUARY 1974

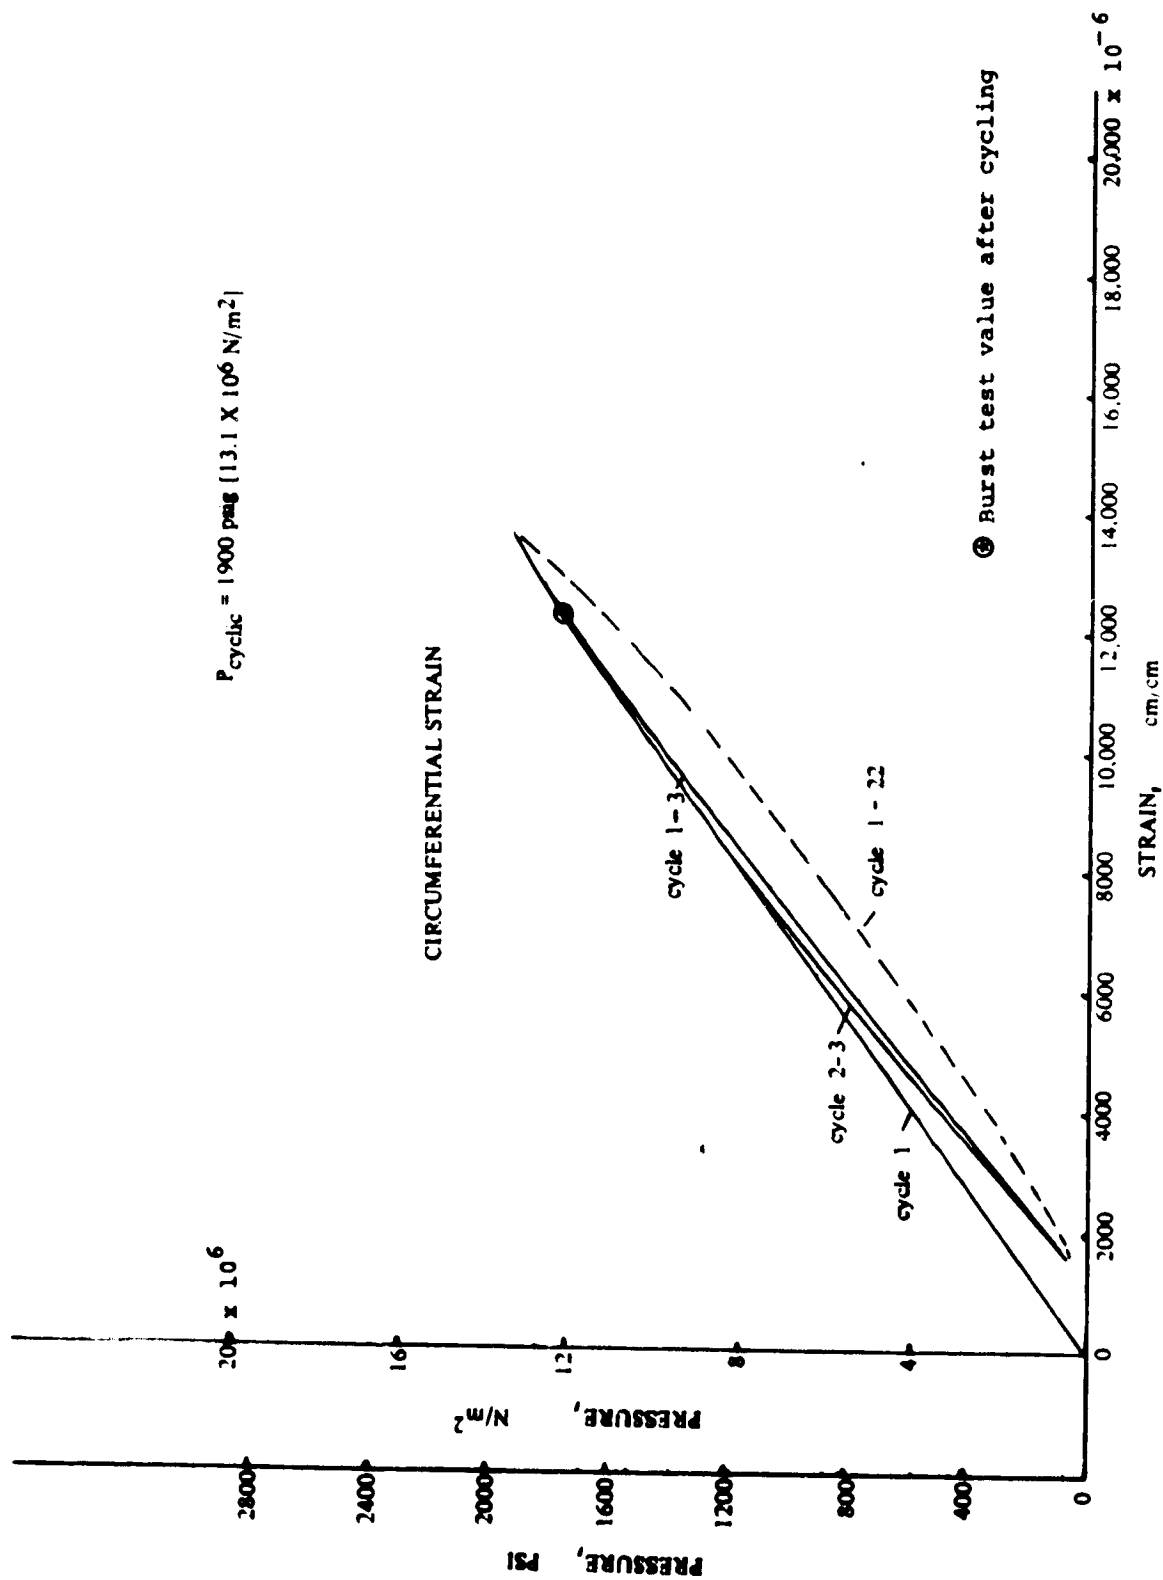
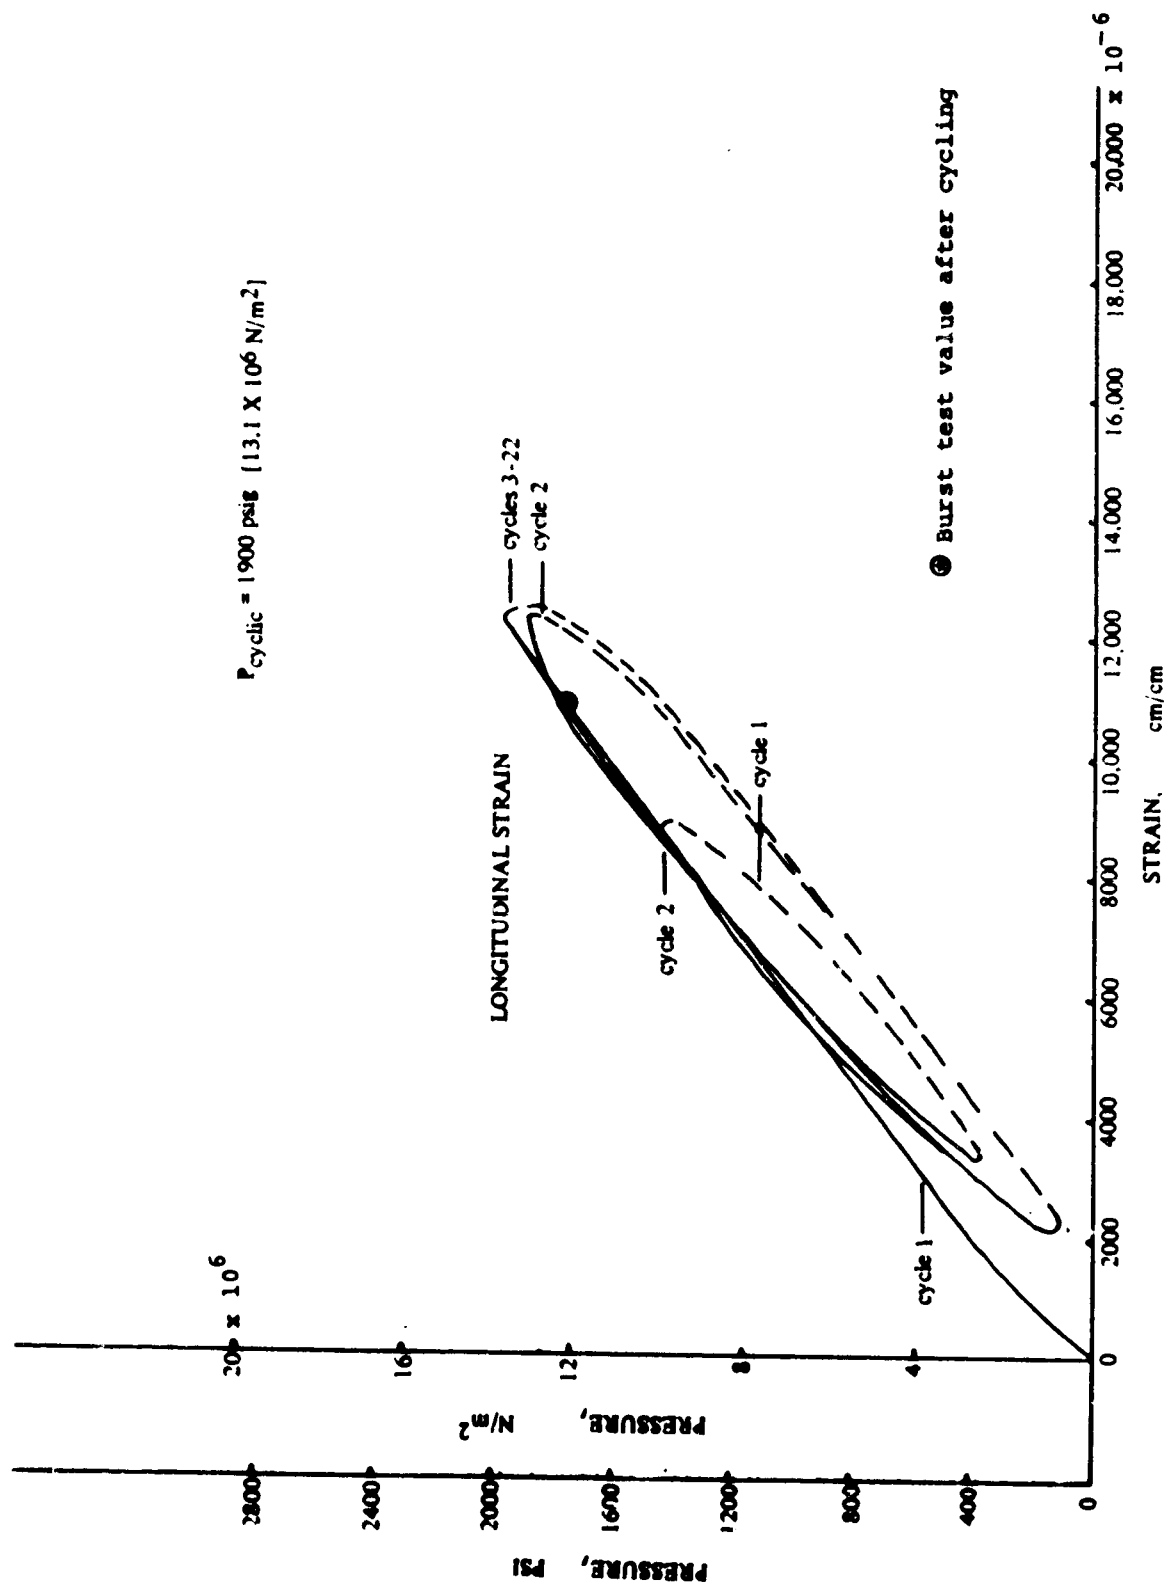
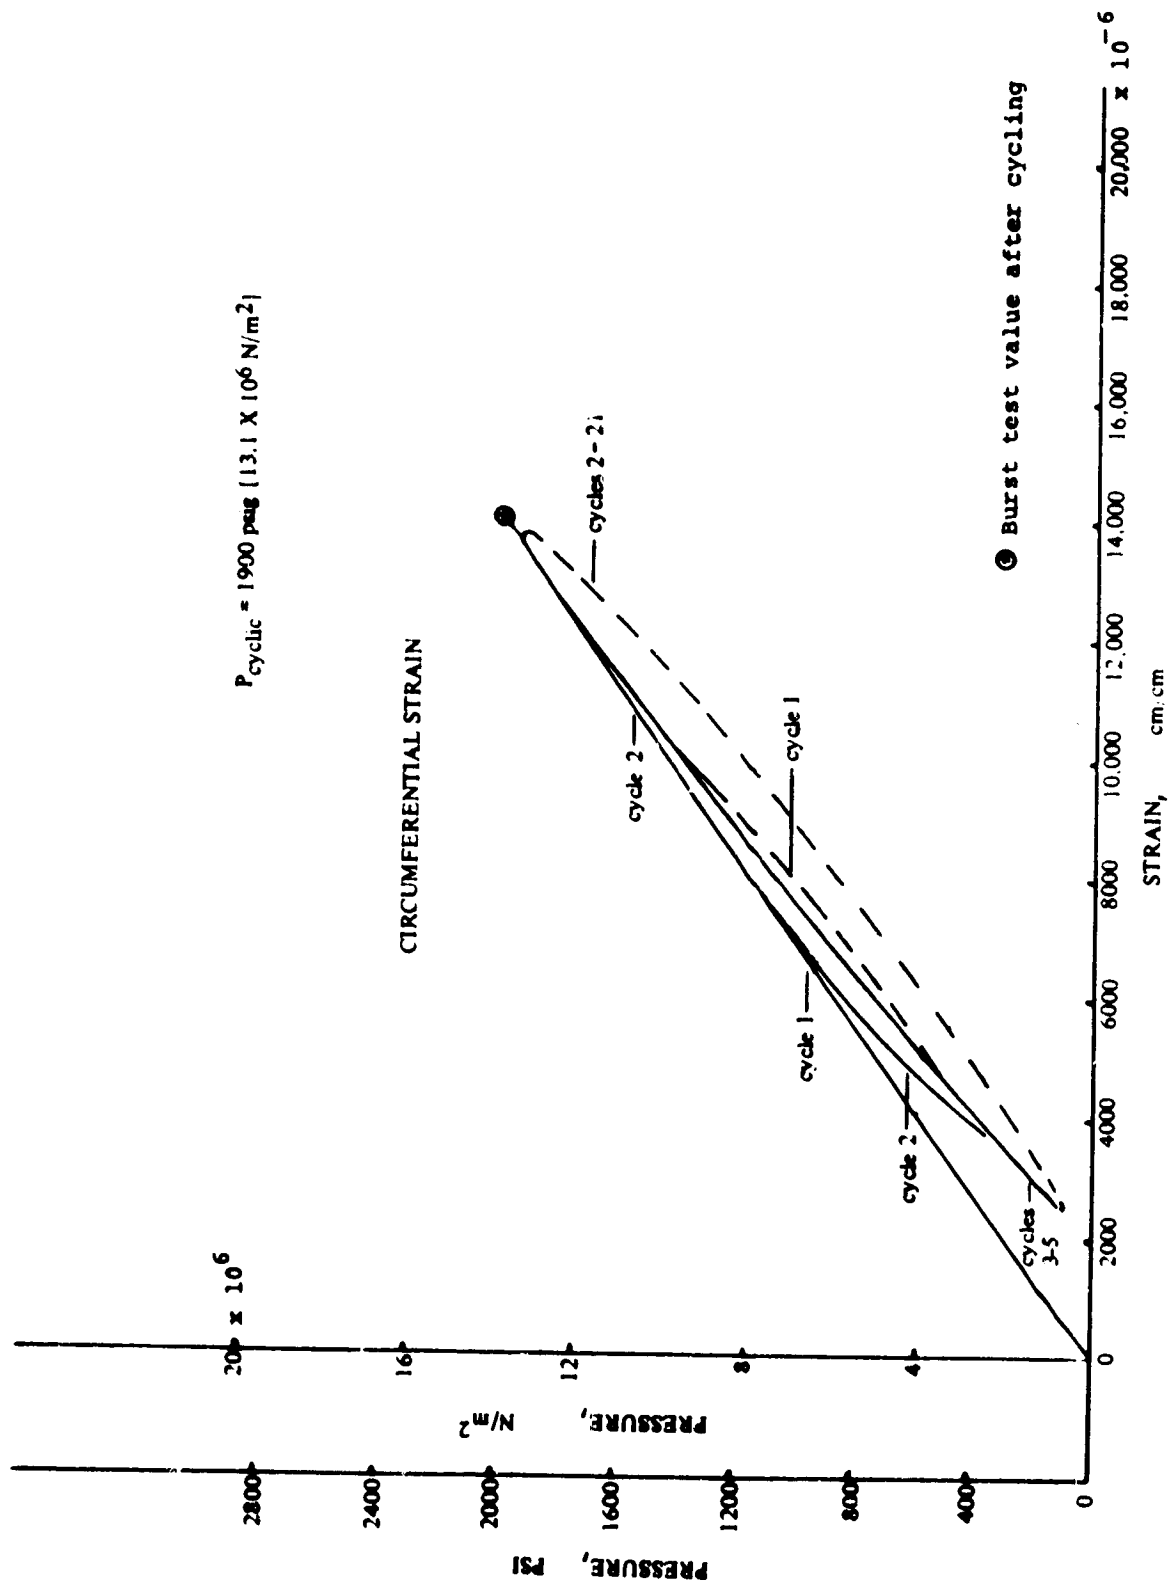
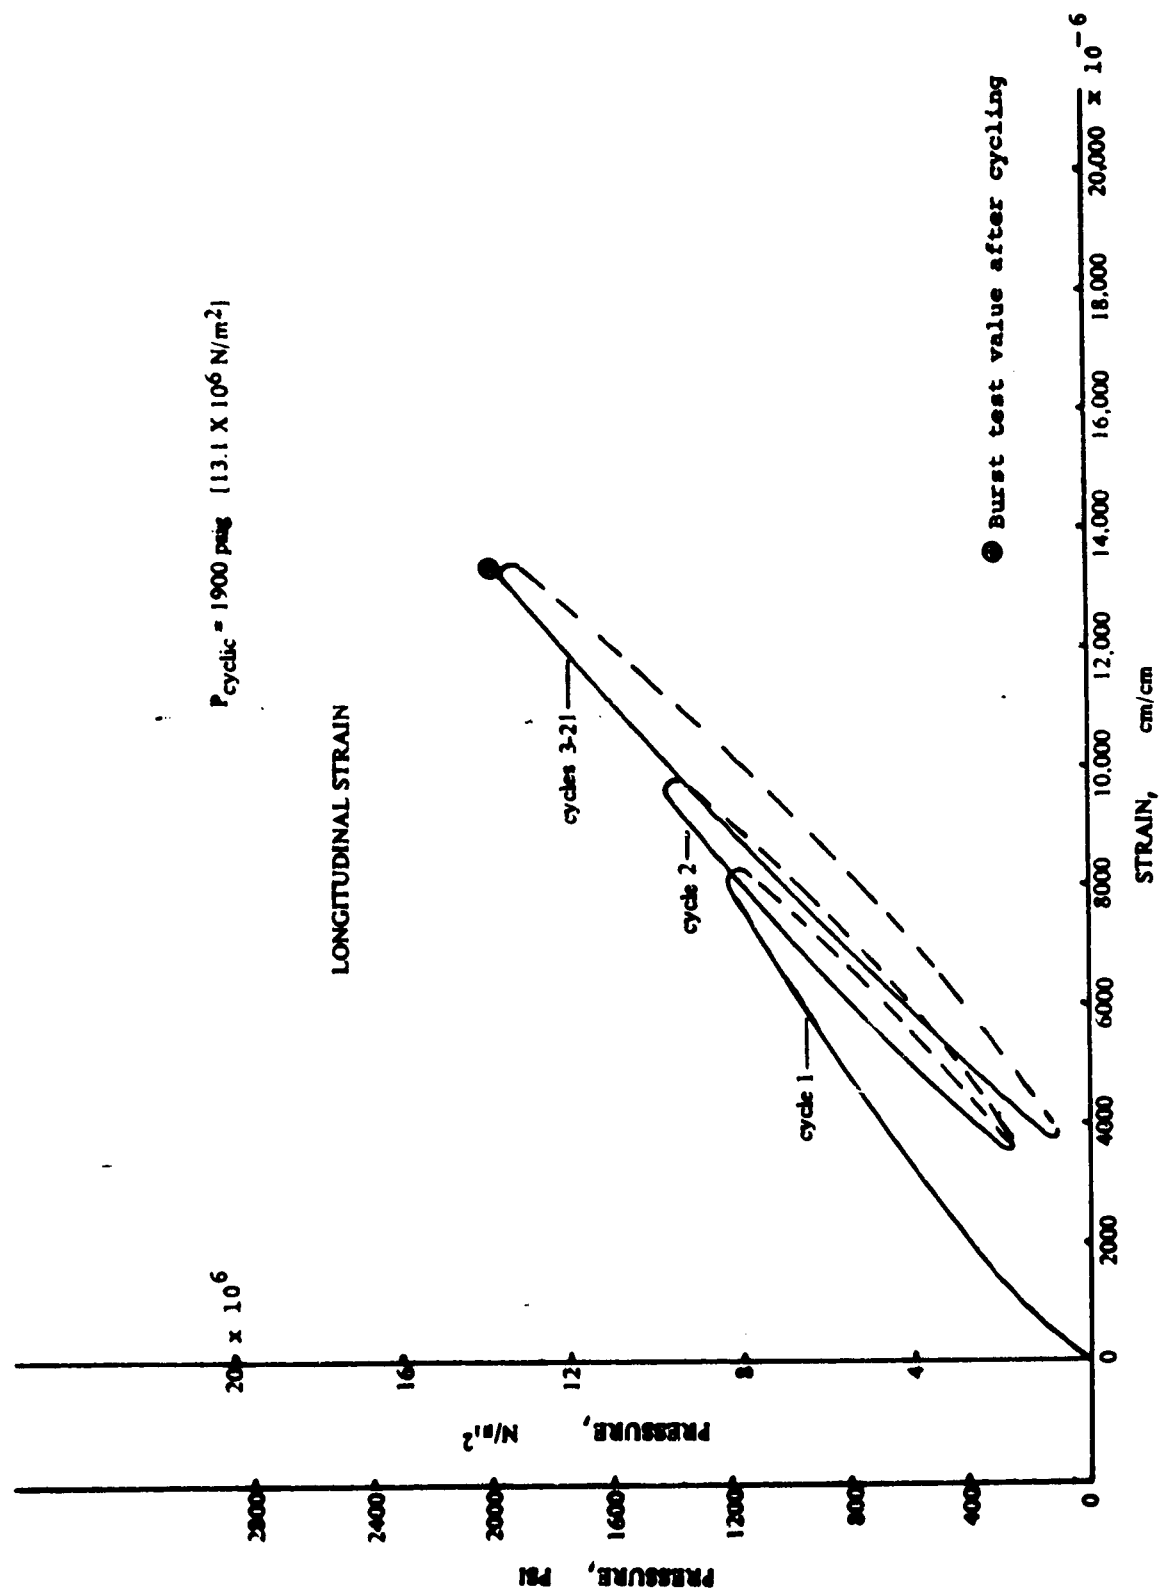
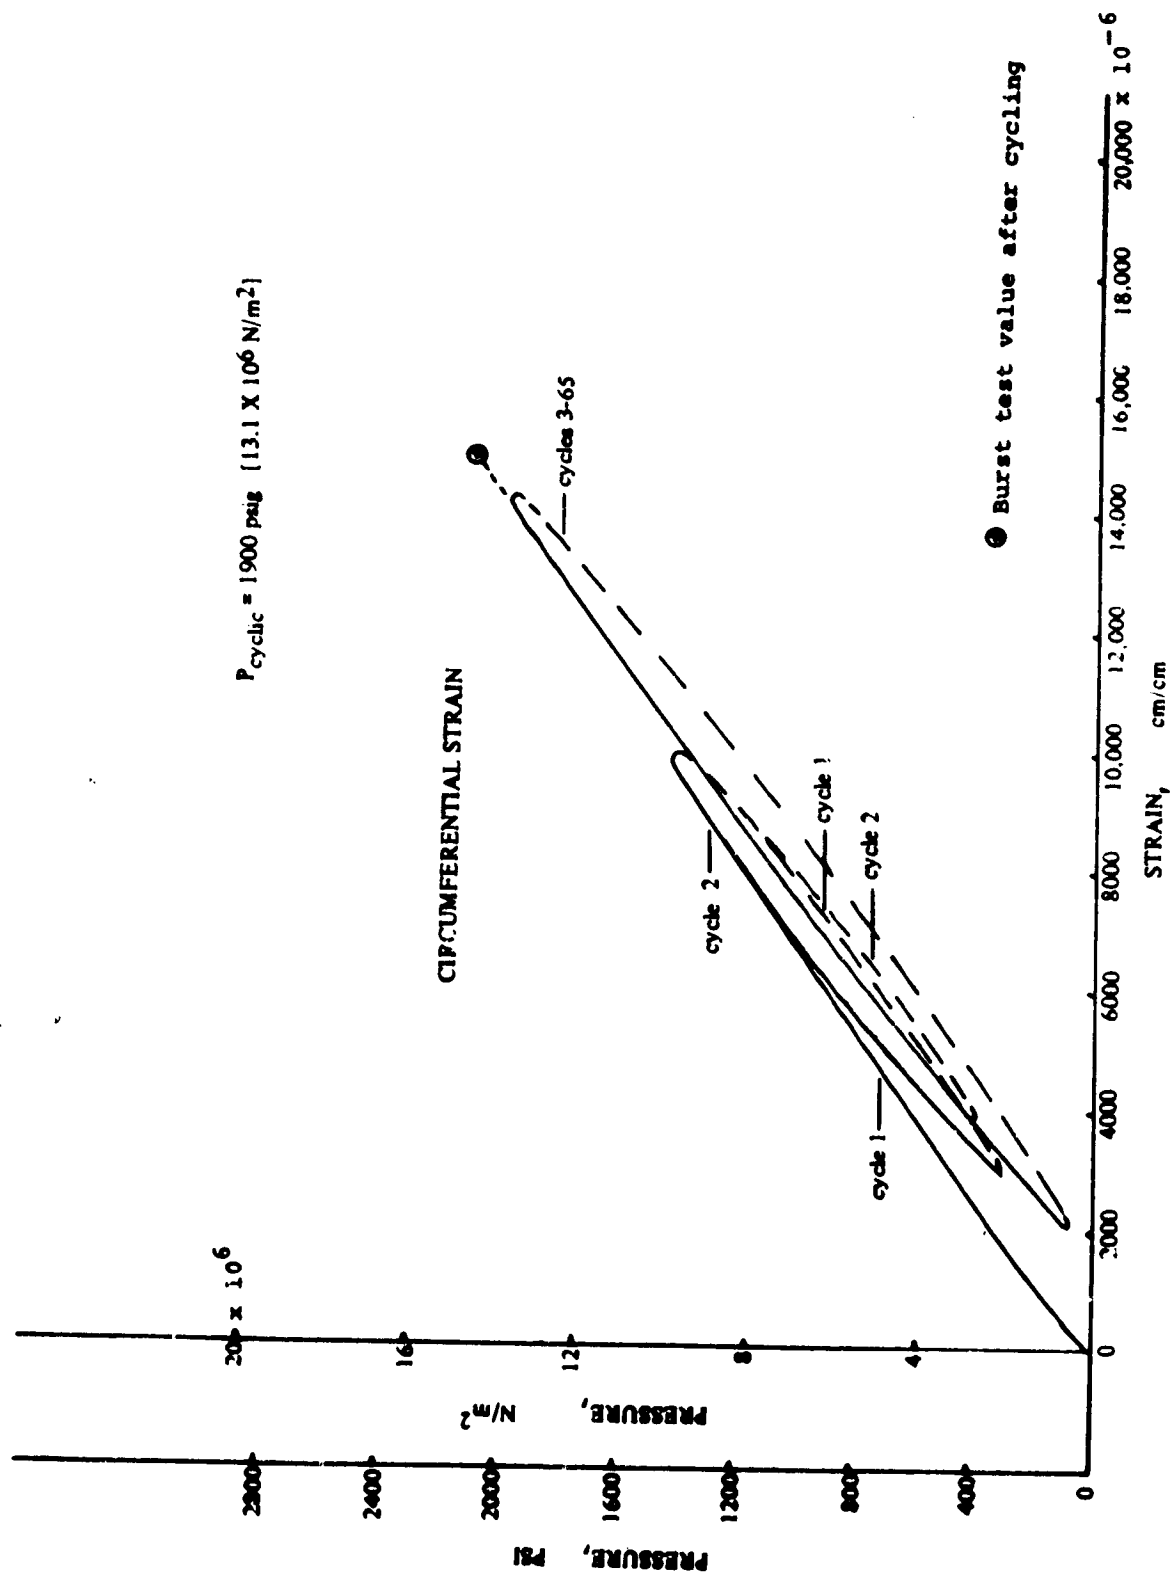
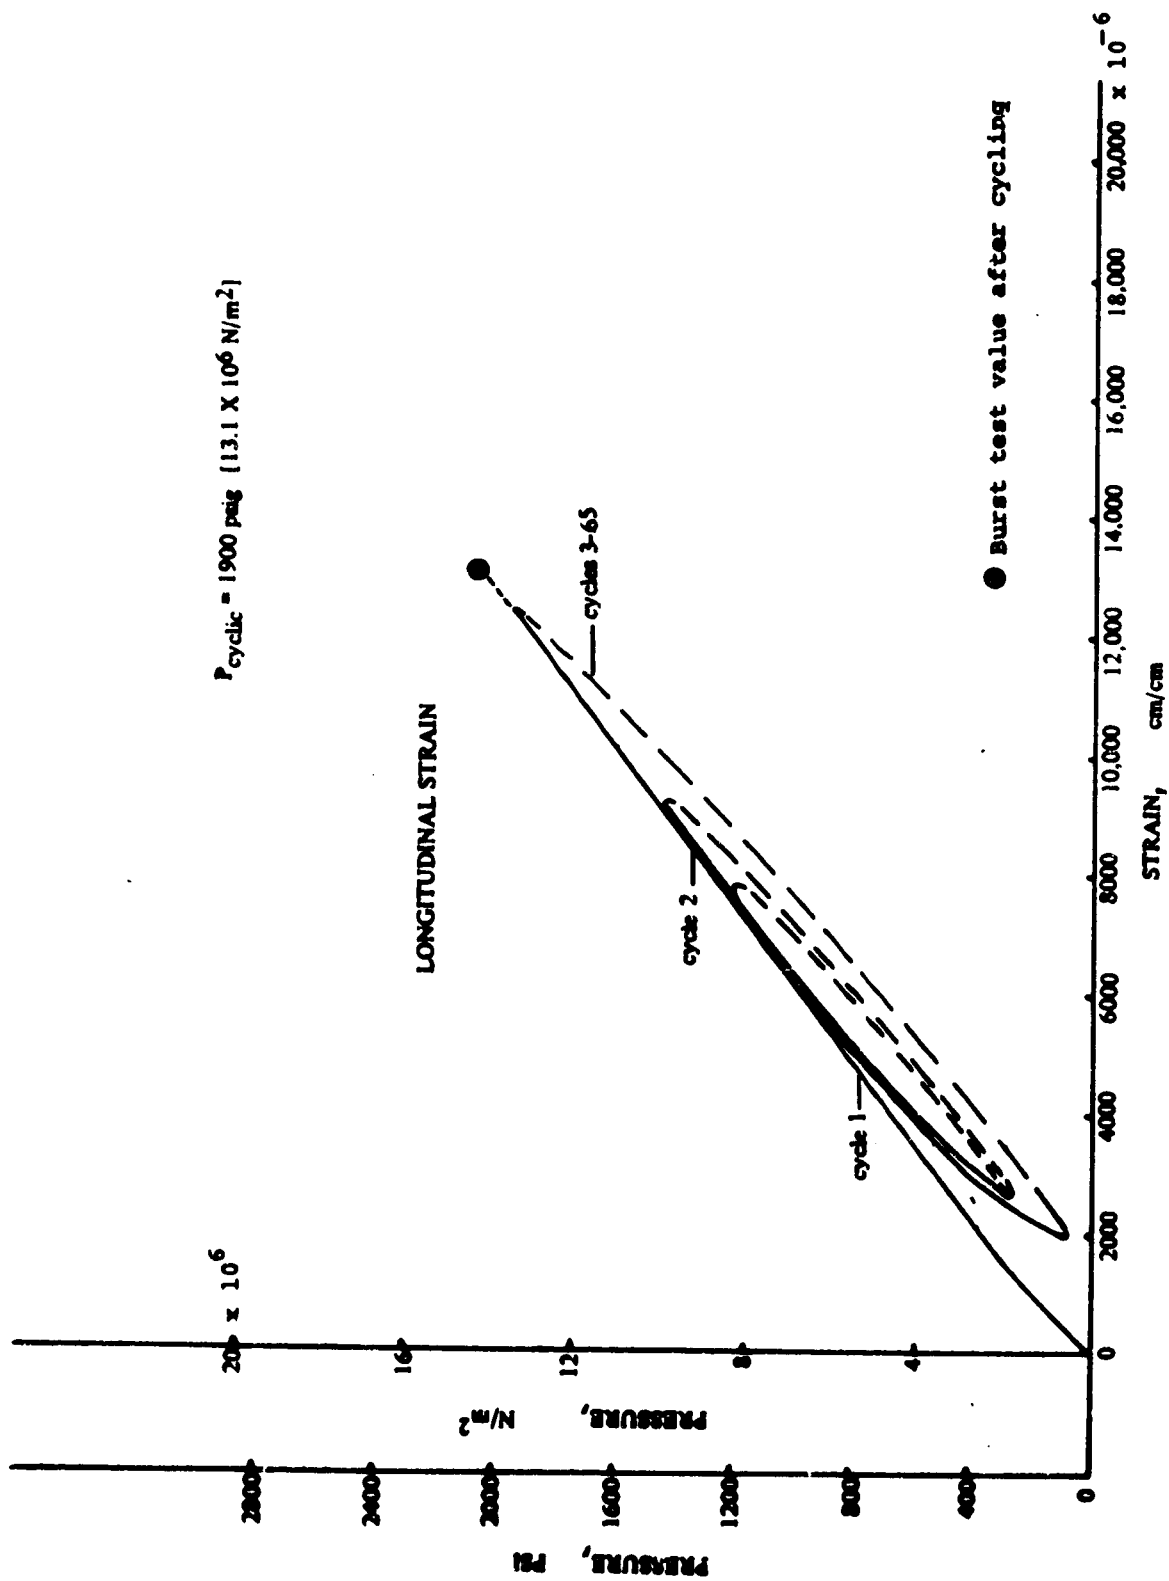
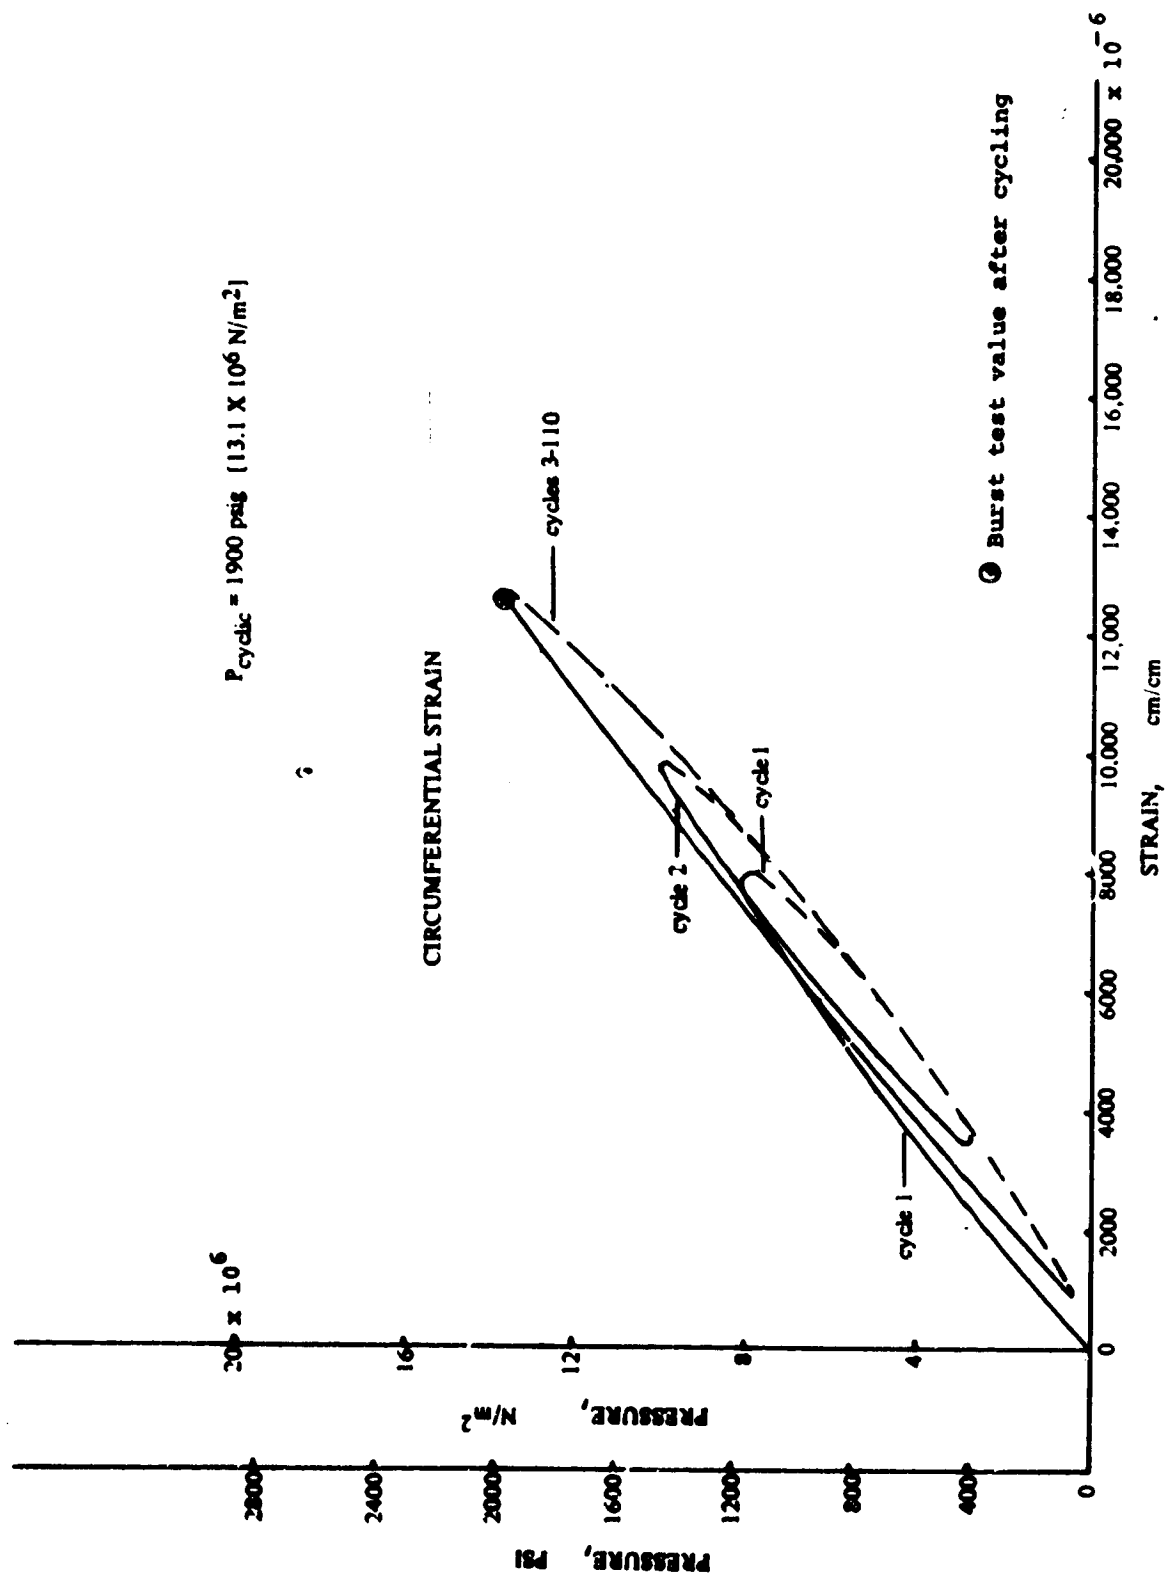
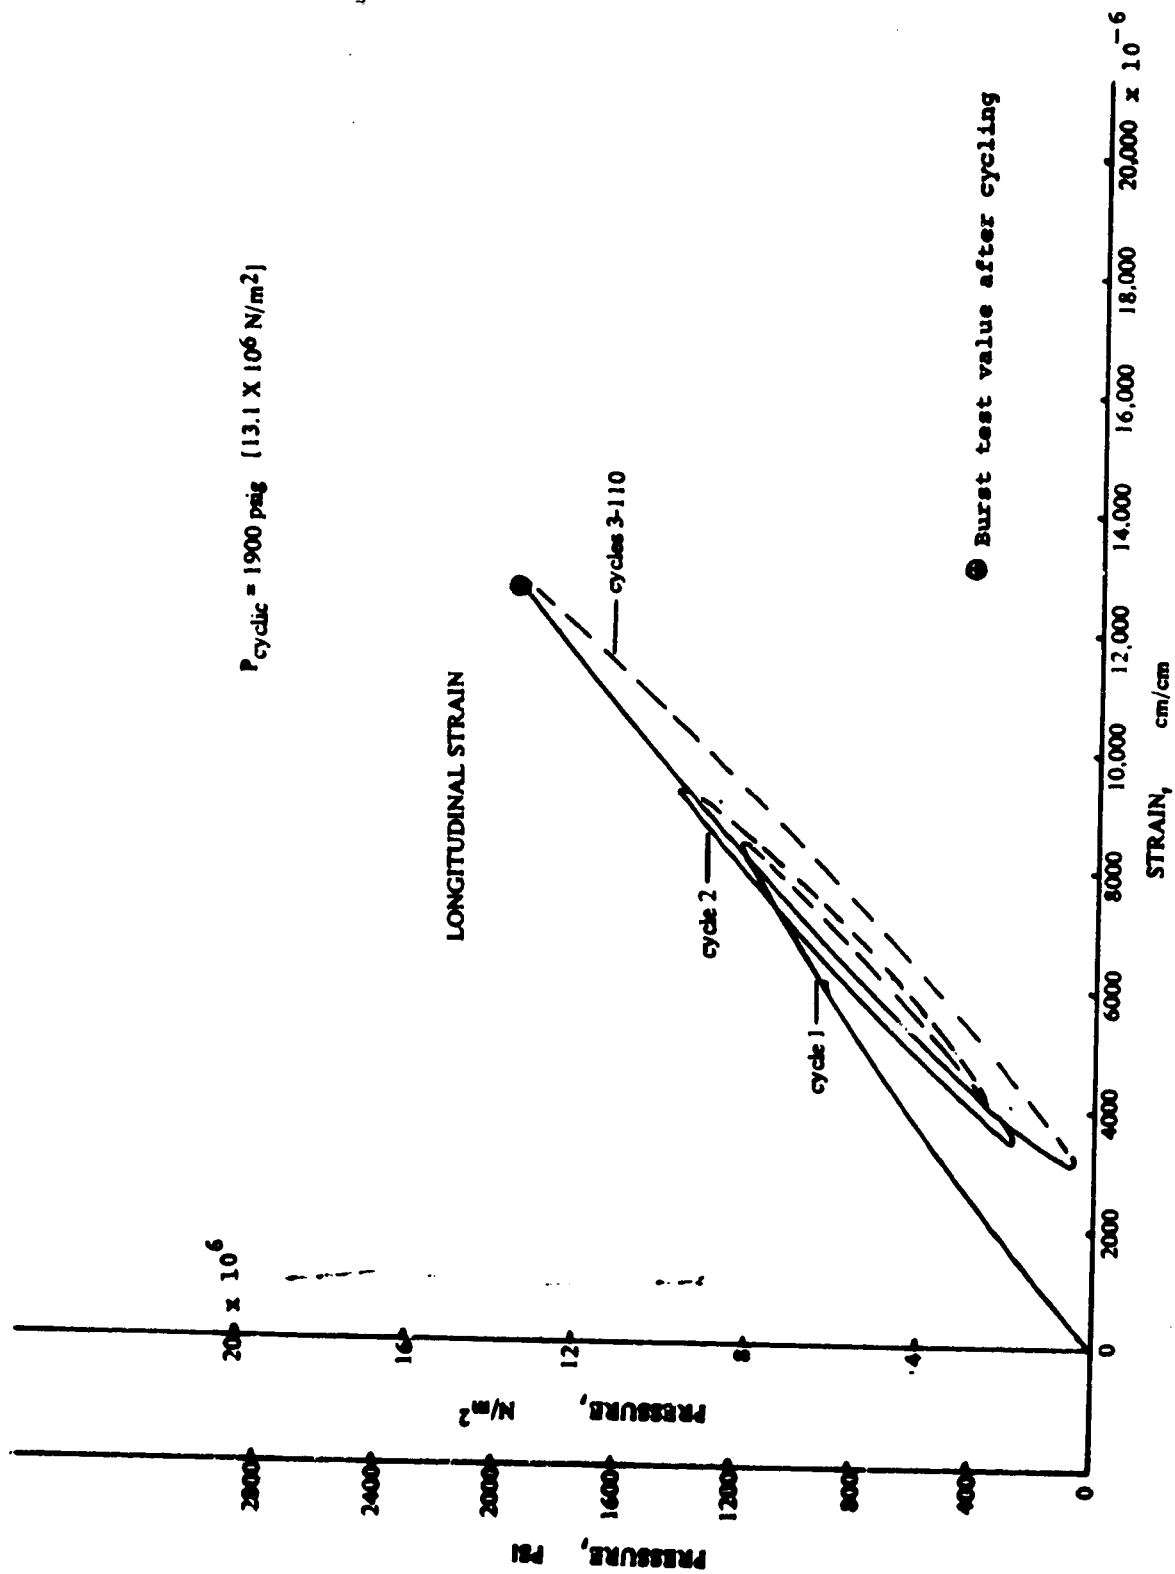
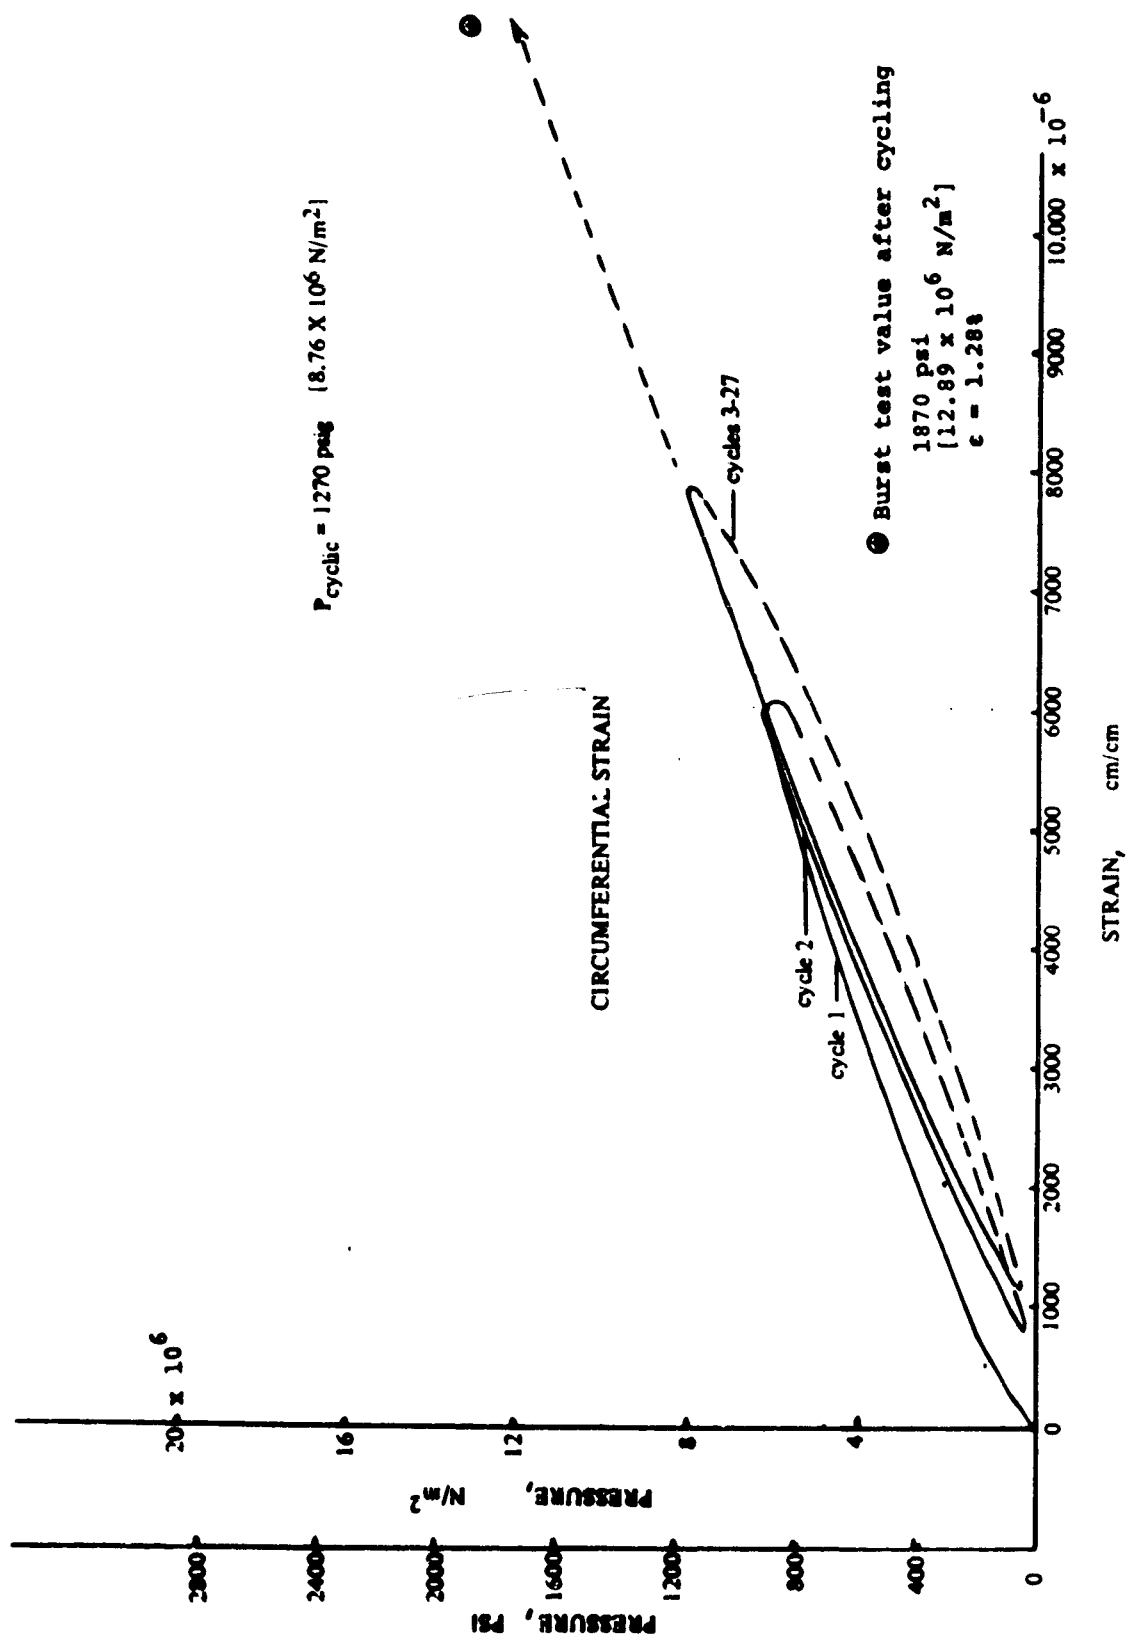
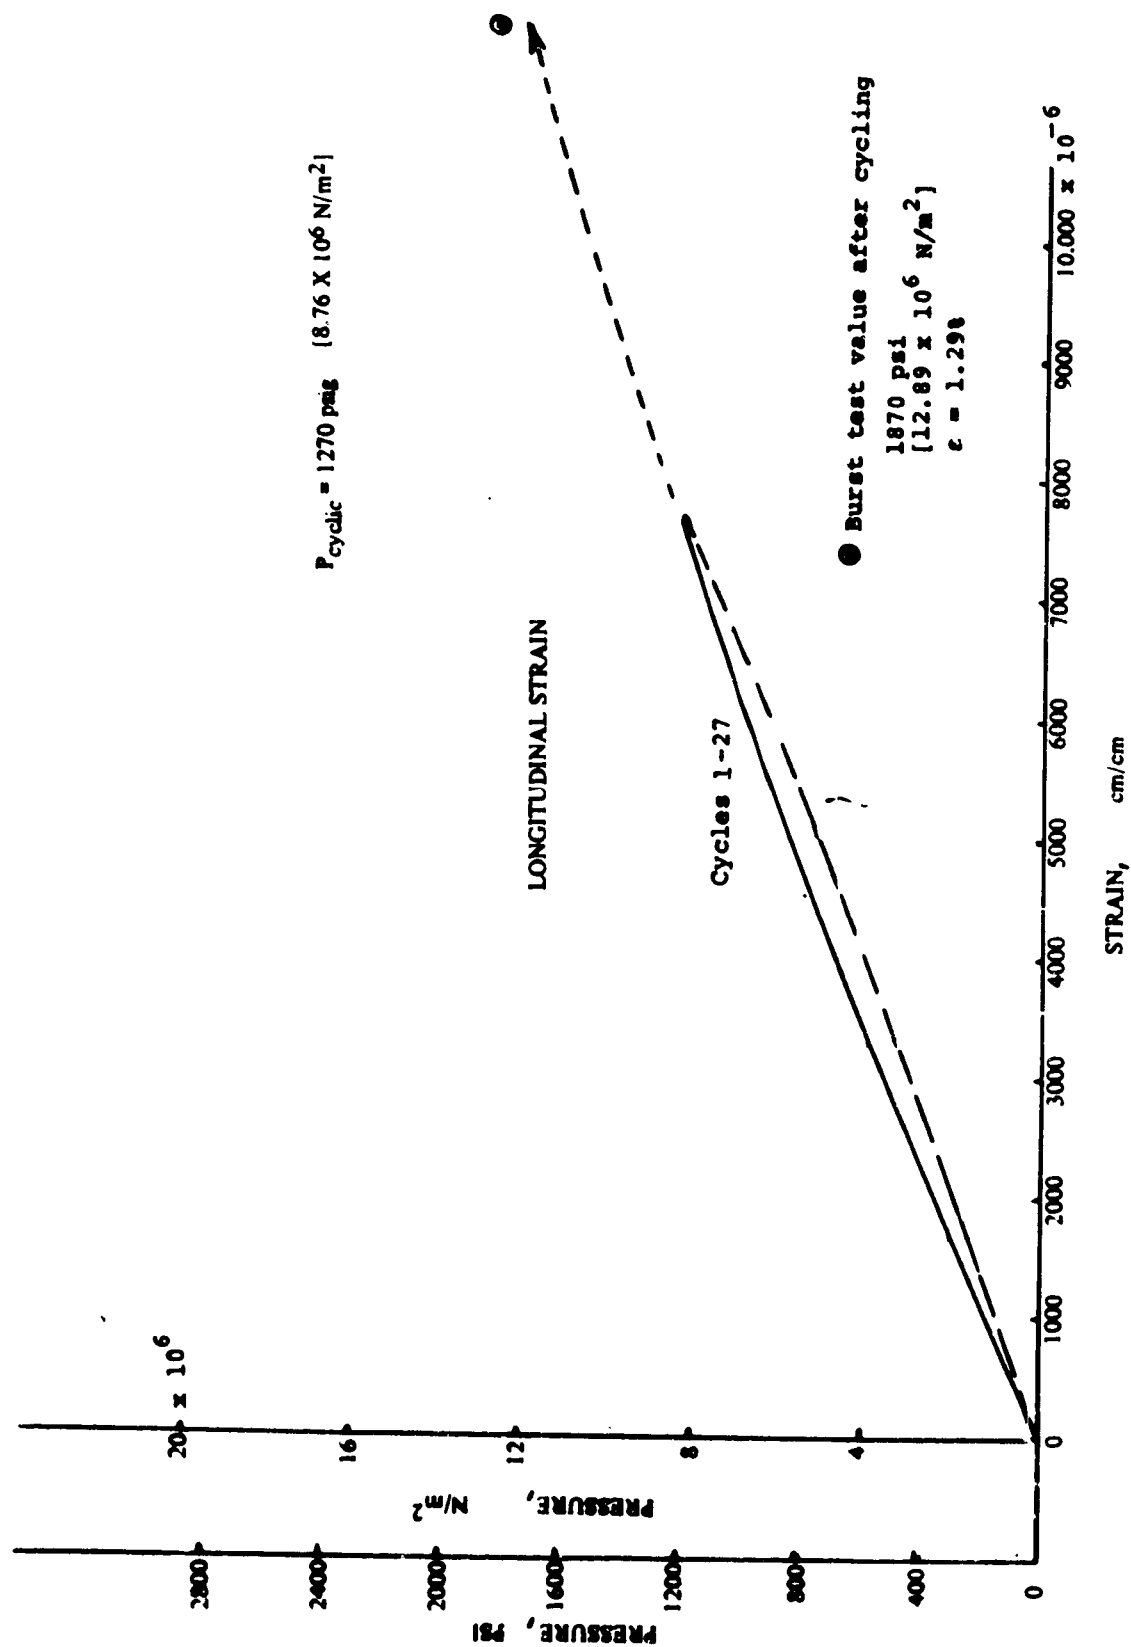
Figures 31 through 62 show the stress-strain curves for each vessel in both the longitudinal and circumferential directions. In reviewing the curves, it should be noted that the first cycle and in some cases the second cycle were not pressurized to the peak cyclic pressure since the instrumentation used required one or two cycles to obtain an accurate pressure setting.

All the vessels, whether cycled at 50% or 75% of ultimate, reached a state of equilibrium after about the third pressure cycle. Thereafter, very little change occurred in either the vessel modulus or the hysteresis loop. However, the stress-strain curve of the metal-lined composite vessel in this equilibrium condition was not as linear as an uncycled vessel. This is evident by comparing the stress-strain curves of vessels 7-18 to those of vessels 1-6. On the other hand the modulus of the vessels did increase by a value of $\sim 1-2 \times 10^6$ psi ($0.7 - 1.4 \times 10^{10}$ N/m²) as a result of cycling.

had considerable hysteresis and did not maintain a linear stress-strain behavior. The stress-strain curves for vessels 19-22 during cycling compare favorably to the uncycled metal-lined tanks (No. 1-6). In fact the stress-strain relationship for vessel No. 22 did not change over 2493 pressure cycles. No indication of impending failure could be detected from either the longitudinal or circumferential strains in that vessel.

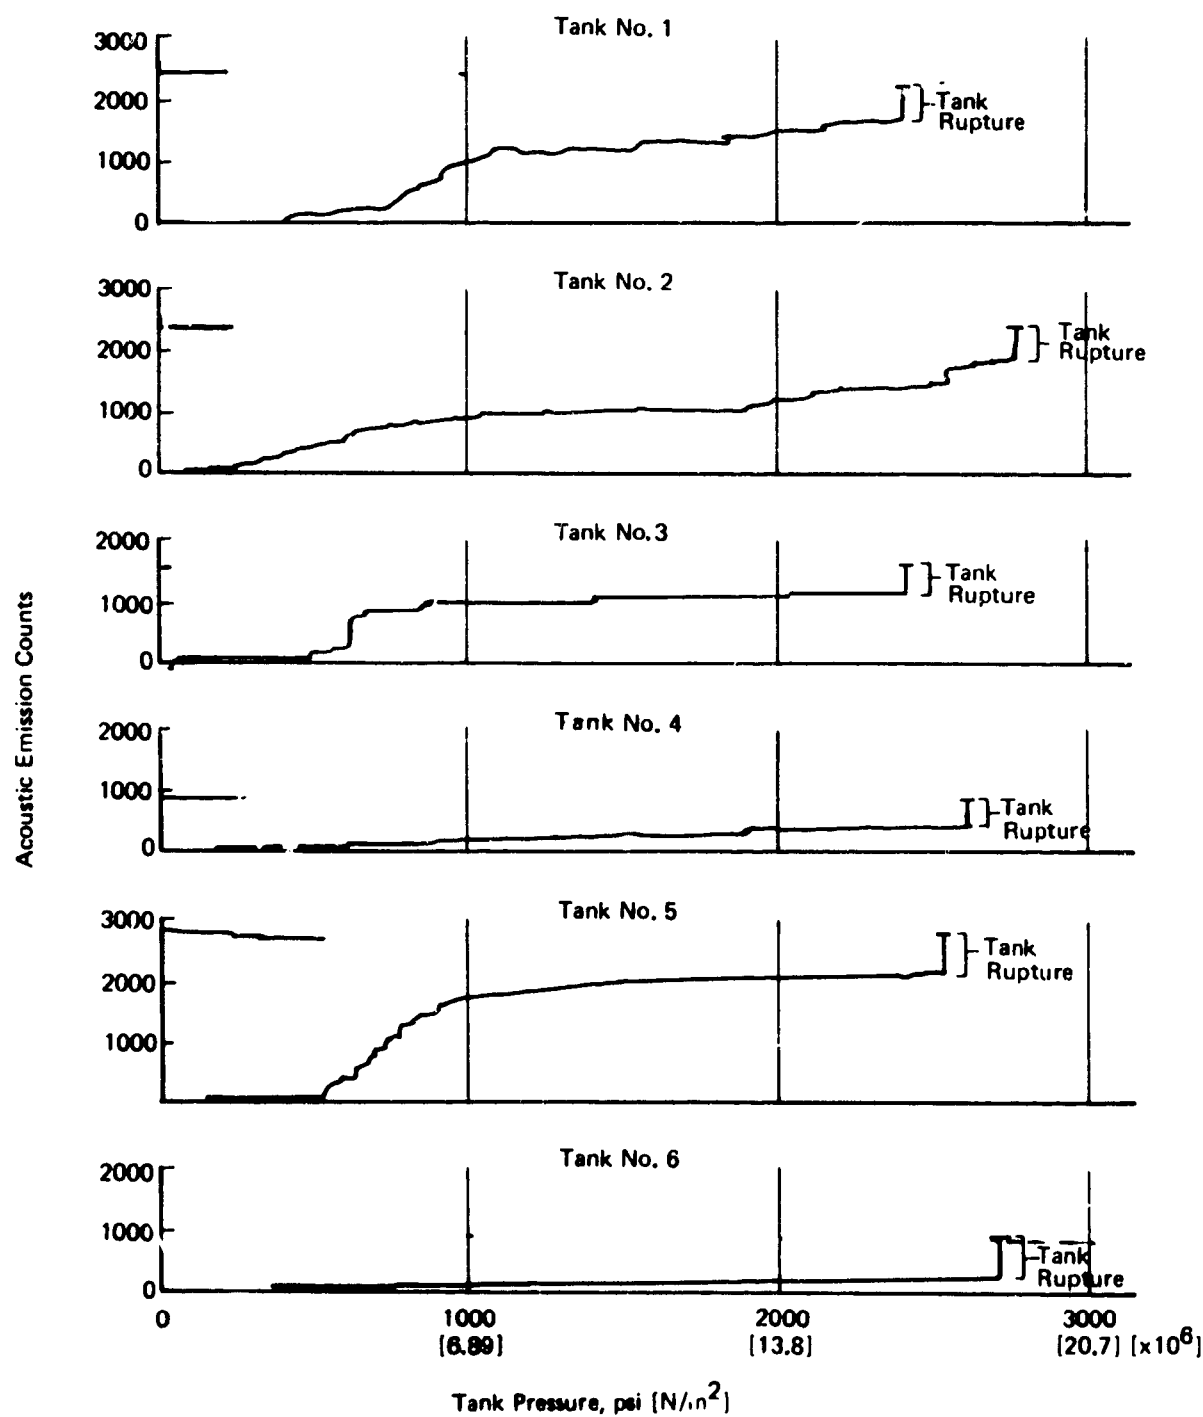
Figure 78: Acoustic Emission Data from Vessel Burst Tests

Vessels No. 1-6 were burst tested and the acoustic emission curve for each is shown in Figure 78. Each of the vessels contained a stainless steel liner which proved to be a detriment to the acoustic studies. The emissions from the liner were of such high magnitude when compared to those emitted by the composite that the latter emissions were lost in the background noise. This was unfortunate since it was the emissions from the composite that was of primary concern. In reviewing Figure 78 it can be noted that the curves contain no severe spikes indicative of filament breakage, resin crazing or other high energy releases typical of composite fracture, until immediately prior to burst. In a previous program, Reference 1, it was shown that PRD-49 composites show relatively little acoustic activity until relatively high stress levels are attained (>80% of ultimate). Excluding the noise of the liner, similar results were obtained in this program but because of the high background noise, impending composite failure could not be detected prior to reaching approximately 98% of ultimate strength. At that level of sensitivity the technique is not satisfactory as a non-destructive quality assurance test technique.
